TITLE: UNDERWRITERS LABORATORIES FIRE TESTS OF
SPRAYED POLYURETHANE FOAM APPLIED
DIRECTLY TO METAL ROOF DECKS

AUTHOR: R. L. Alumbaugh and S. R. Conklin

DATE: December 1983

NAVAL CIVIL ENGINEERING LABORATORY
PORT HUENEME, CALIFORNIA 93043

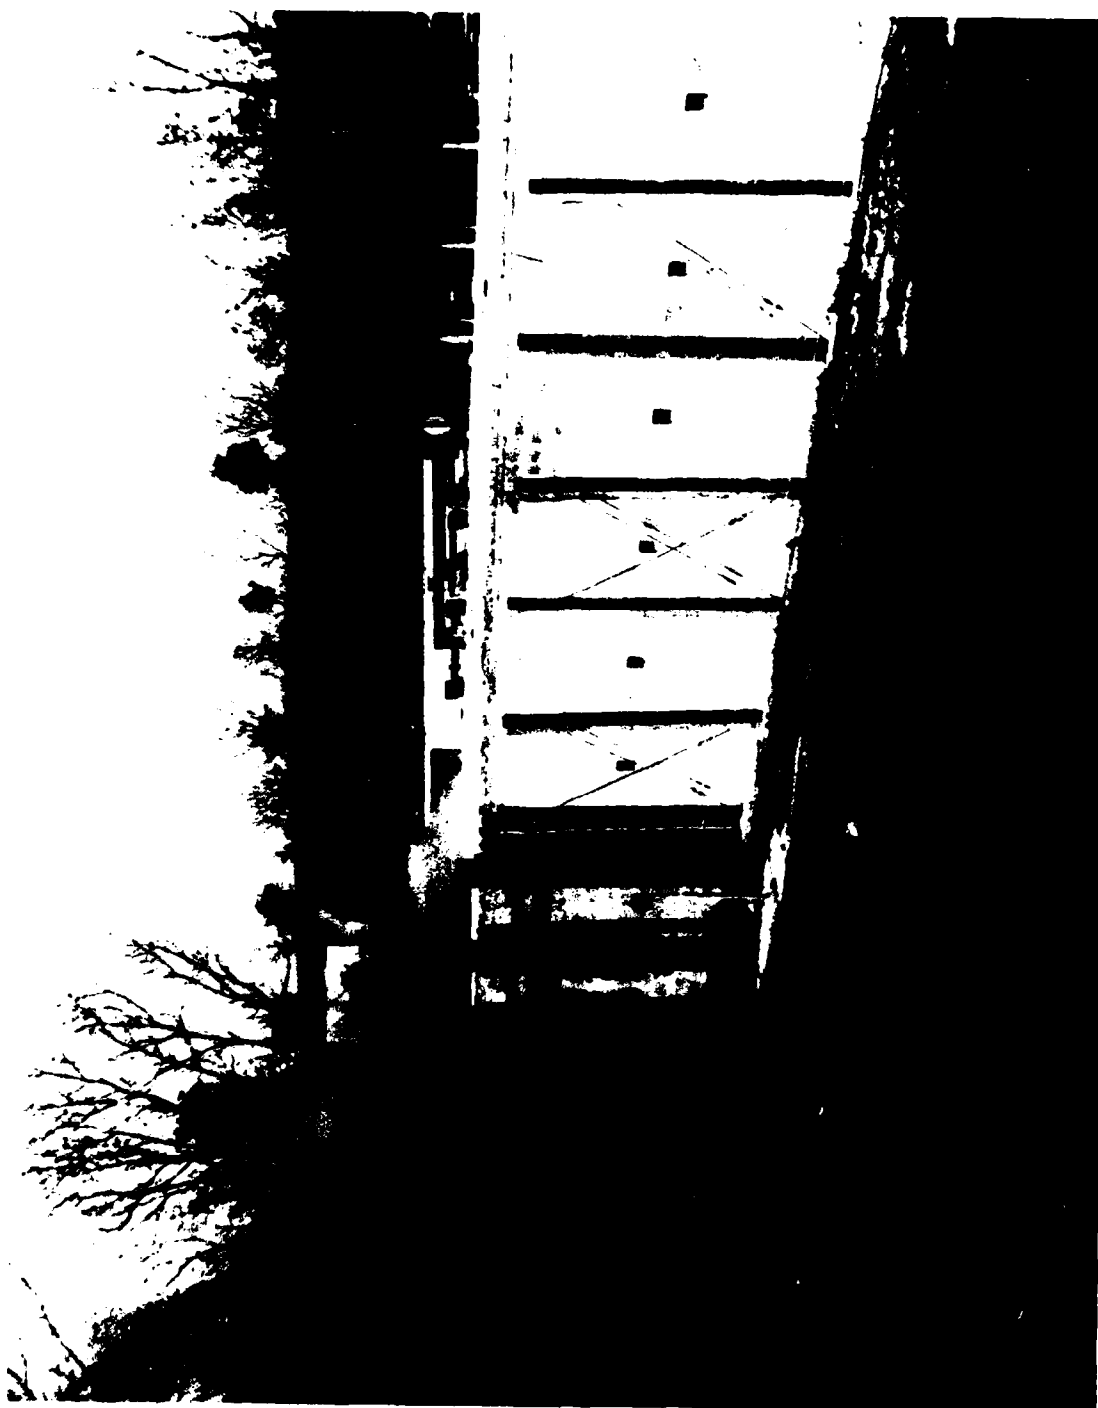
Three minutes after heptane ignition, light smoke was emitted from the exterior roof edges along the perimeter of the fire end. Figure 1 shows the exterior of the roof during the test burn. After 4 minutes, smoke began issuing from the joints in the underside of the roof, becoming very dense after 8 minutes. This obscured vision of the burners from the flue end; however, smoke had cleared within the structure after 11-1/2 minutes. The density of the smoke fluctuated but did not again obscure vision within the structure. Figure 2 shows the burners from the flue end 5 minutes after initiation of the test, while Figure 3 gives the same view about 20 minutes after test initiation. Note the lack of smoke inside the White House. It is understood that when testing a conventional or standard built-up roof (BUR) assembly, dense smoke fills the interior of the White House after 4 to 7 minutes, and the density remains constant thereafter until the end of the 30-minute test period; i.e., the very dense smoke does not clear as it did with the foam roof.

Figure 1. Exterior view of White House structure showing roof during the test.

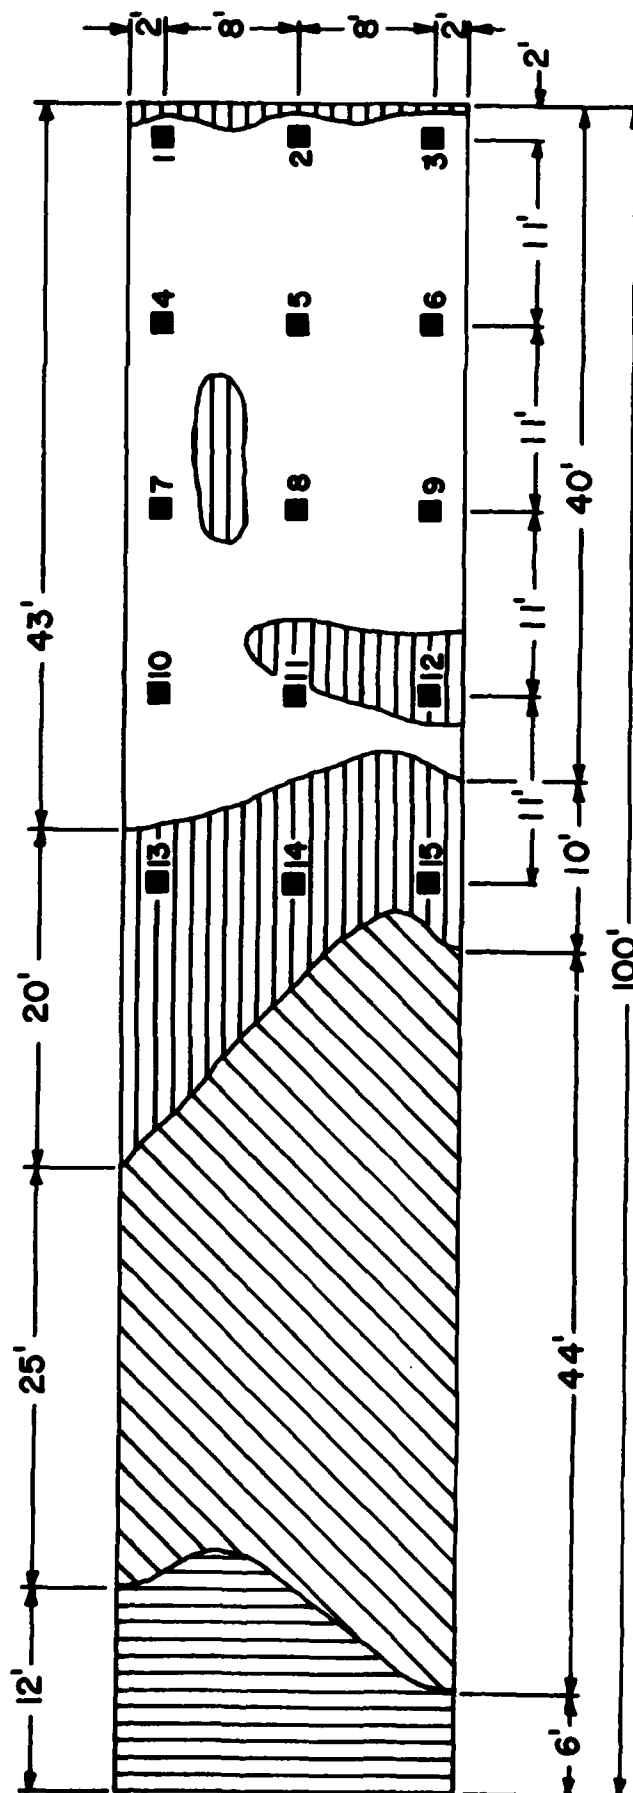
USNC 77
ILL. 20

A sketch showing the overall post test observations of damage is shown by ILL. 19. Cross-sections were taken to visually observe the extent of damage to the foamed plastic material. The cross-sections taken nearer the fire end of the structure were reduced in thickness due to the fire exposure. The table below summarizes these observations as defined according to three damage levels.

OBSERVATIONS AFTER TEST

EXTERIOR

-   STEEL DECK EXPOSED
-   ROOF COVERING CHARRED THROUGH ENTIRE THKNS.
-   ROOF COVERING BUBBLED

-   STEEL DECK RIPPLED, SEVERAL DECK SIDELAP JOINTS OPEN
-   STEEL DECK RIPPLED
